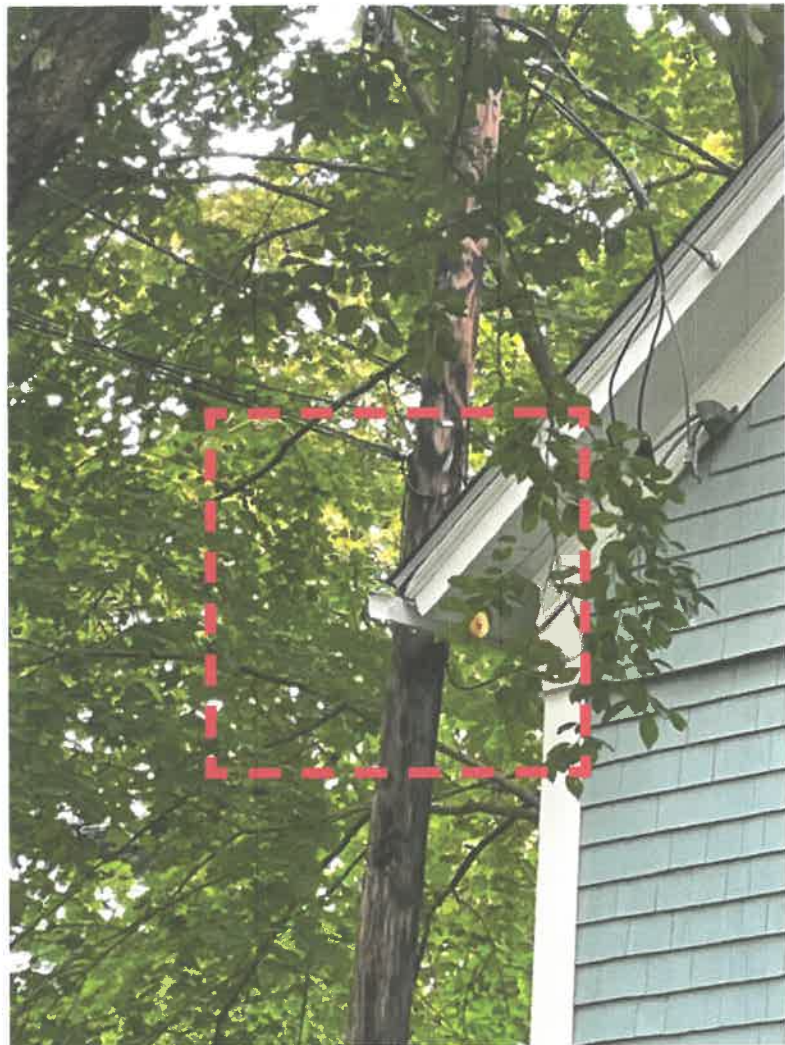
Existing Condition:  
The pole leaning against eave and gutter.

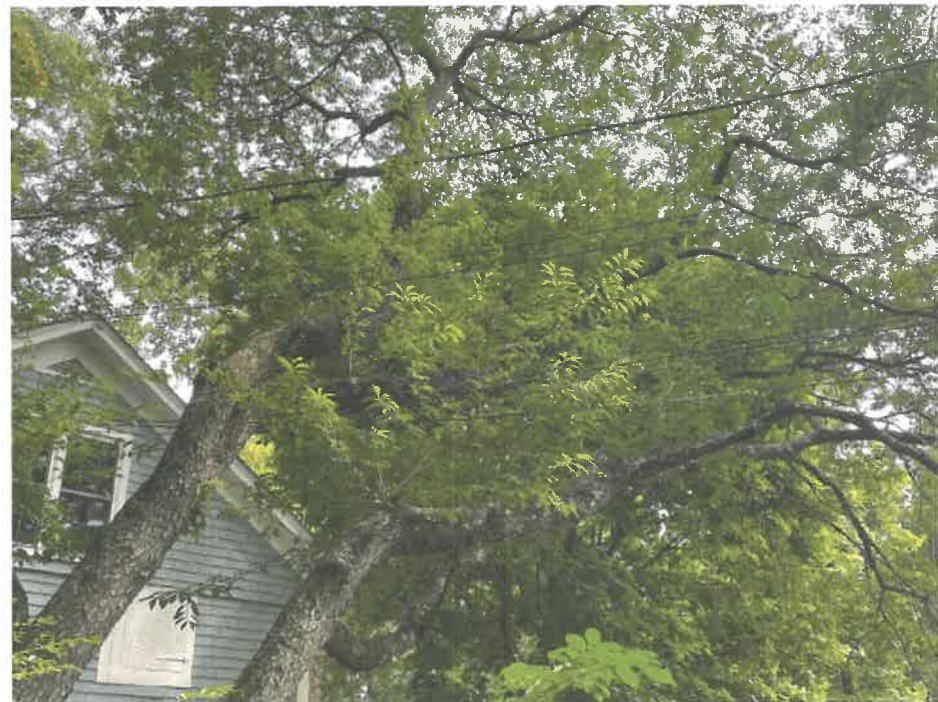
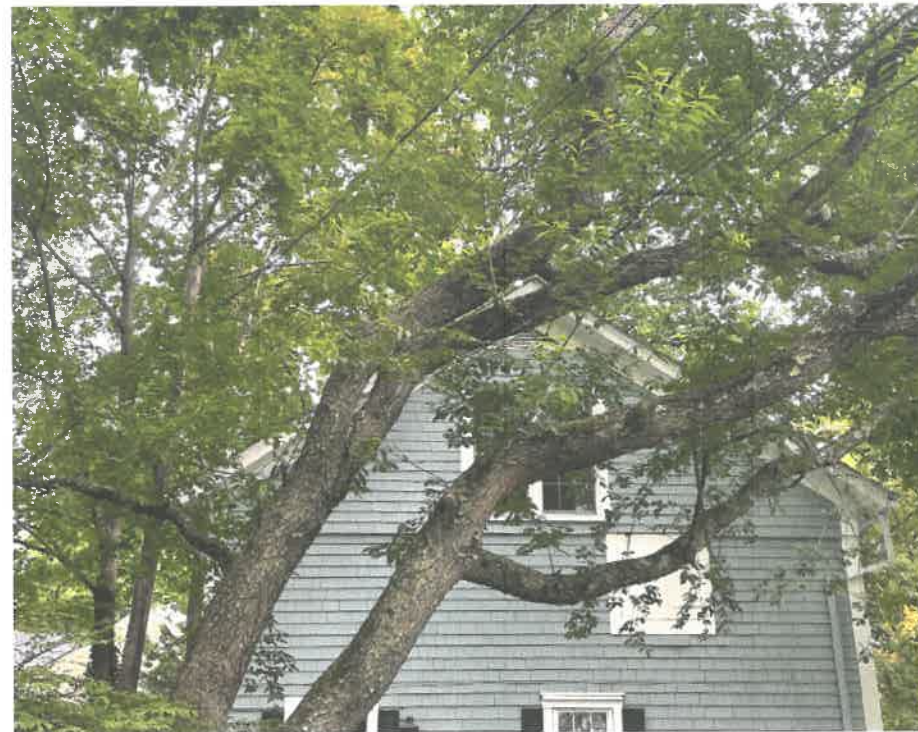
Below: Wires crossing Pat's property through a tree that needs to be remove.

Existing Condition:  
The pole is very short and it is urrently leaning and in contact with eaves and gutters.  
The existng tree can not be removed until power lines are relocated.

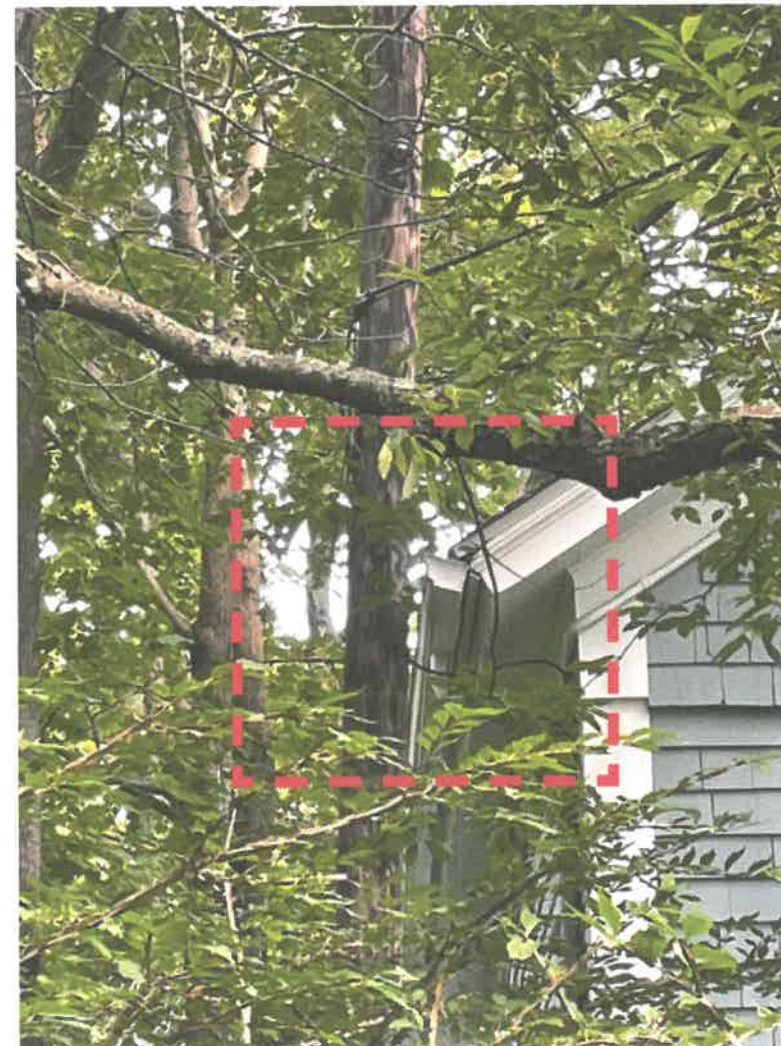
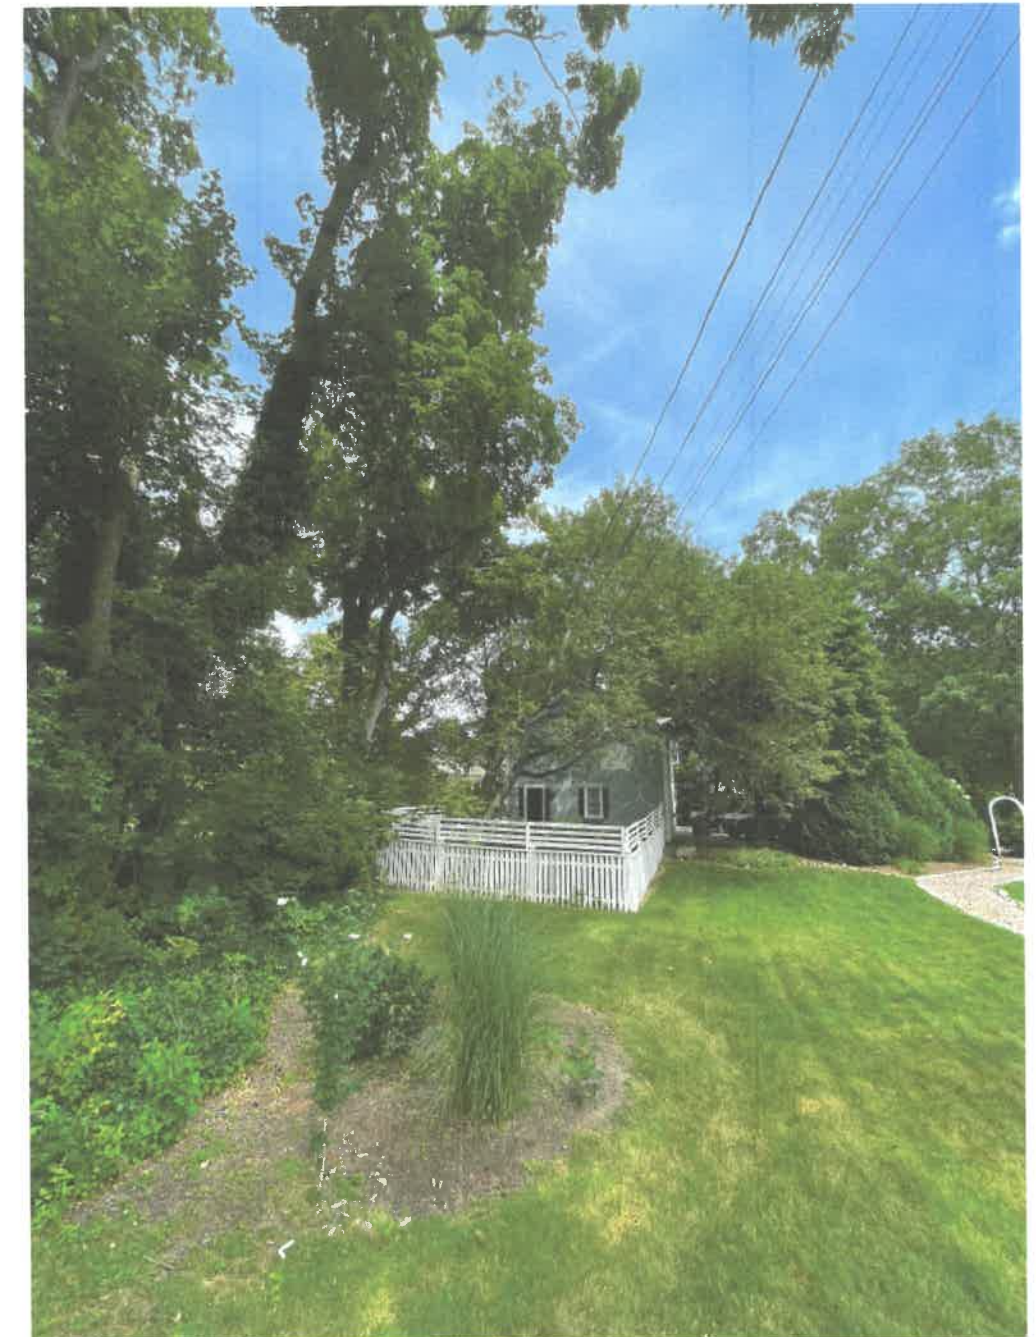
Existing Condition:  
From one pole located on the street three homes are currently connected. The Gagne's and the O'Donnell's power lines cross 30 Rector Street in order to connect to the existing pole at the corner of Pat's home that is located on the O'Donnell's property.
